POMPTON LAKE DAM

PHASE I INSPECTION REPORT

NATIONAL DAM SAFETY PROGRAM

NJ 00249

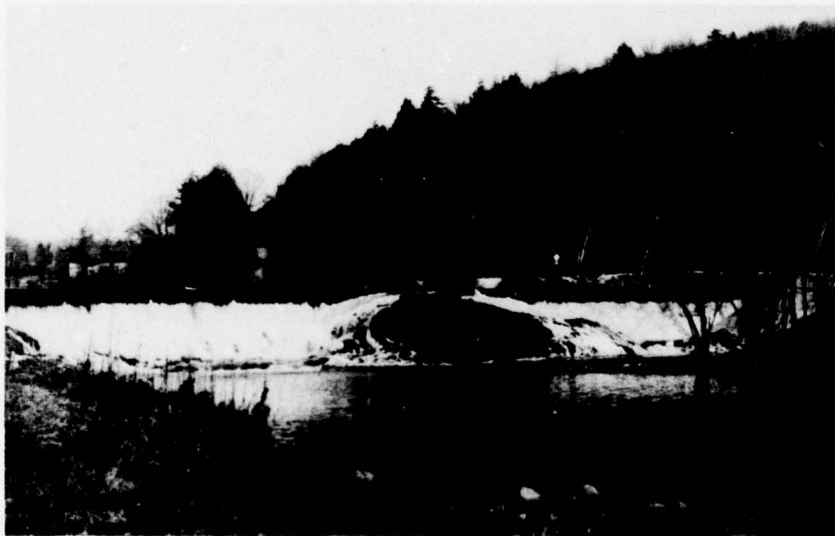
VIEW LOOKING UPSTREAM SHOWING ROCK OUTCROP
AT CENTER AND EROSION OF HIGHWAY EMBANKMENT

Sloughing of the embankment of U.S. Route 202 could be prevented by construction of a retaining wall. The wall could be built outside of the limits of the spillway at the east end of the dam to protect the highway and to improve flow conditions over the dam.

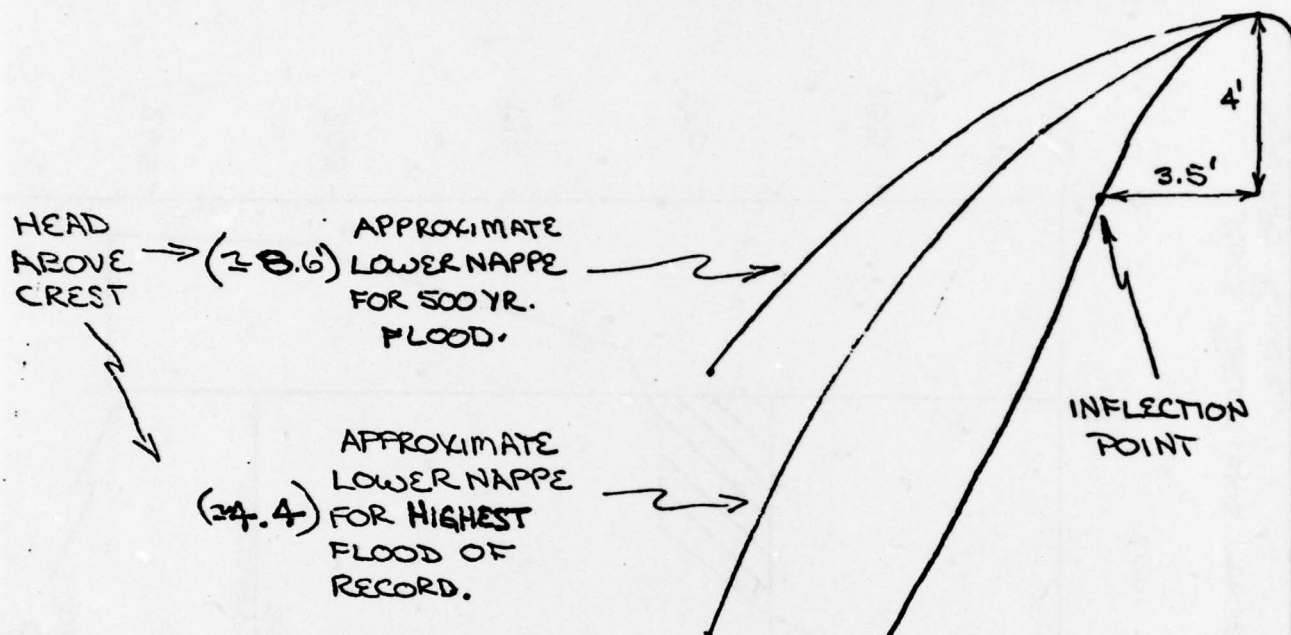
POMPTON LAKES DAM
CROSS-SECTION

DUE TO THE SHARP CURVATURE OF THE DAM CREST, THE LOWER NAPPE OF HIGH DISCHARGES WILL TEND TO SEPARATE FROM THE SPILLWAY FACE, CREATING A ZONE OF SUB-ATMOSPHERIC PRESSURES. USING THE GEOMETRY FROM THE CREST TO THE INFLECTION POINT, AND THE FORMULA FOR THE LOWER NAPPE, $2 \cdot H_D^{.85} \times Y = X^{1.85}$ (WATERWAYS EXPERIMENT STATION), H_D FOR POMPTON LAKES DAM IS 1.32 FEET. HIGHER HEADS WILL PRODUCE SUB-ATMOSPHERIC PRESSURES.
